Hydrogen embrittlement testing and results of full-size ASTM A354 grade BD rods in the SFOBB

H.E. Townsend^{a,*}, K.H. Frank^b, B. Brignano^c and C. Choi^d

Abstract. To determine the hydrogen-embrittlement resistance of anchor rods in the new San Francisco-Oakland Bay Bridge, tensile tests of full-size ASTM A354 Grade BD anchor rods were conducted at very slow load rates. Resistance to embrittlement by hydrogen entering the rods while under load, also referred to as stress corrosion cracking (SCC) or environmental hydrogen embrittlement (EHE), was measured by performing the slow-load tests in 3.5% sodium chloride (NaCl) solution. Resistance to embrittlement by hydrogen entering the steel during fabrication processes such as hot-dip galvanizing, also referred to as internal hydrogen embrittlement (IHE), was measured by performing the slow-load tests in air. Testing was conducted on rods representing various sizes, different manufacturers, rolled and cut threads, different alloys, as well as galvanized and ungalvanized rods. Following slow-load hydrogen embrittlement tests, mechanical and chemical properties of the test rods were fully characterized, and fracture surfaces were exam

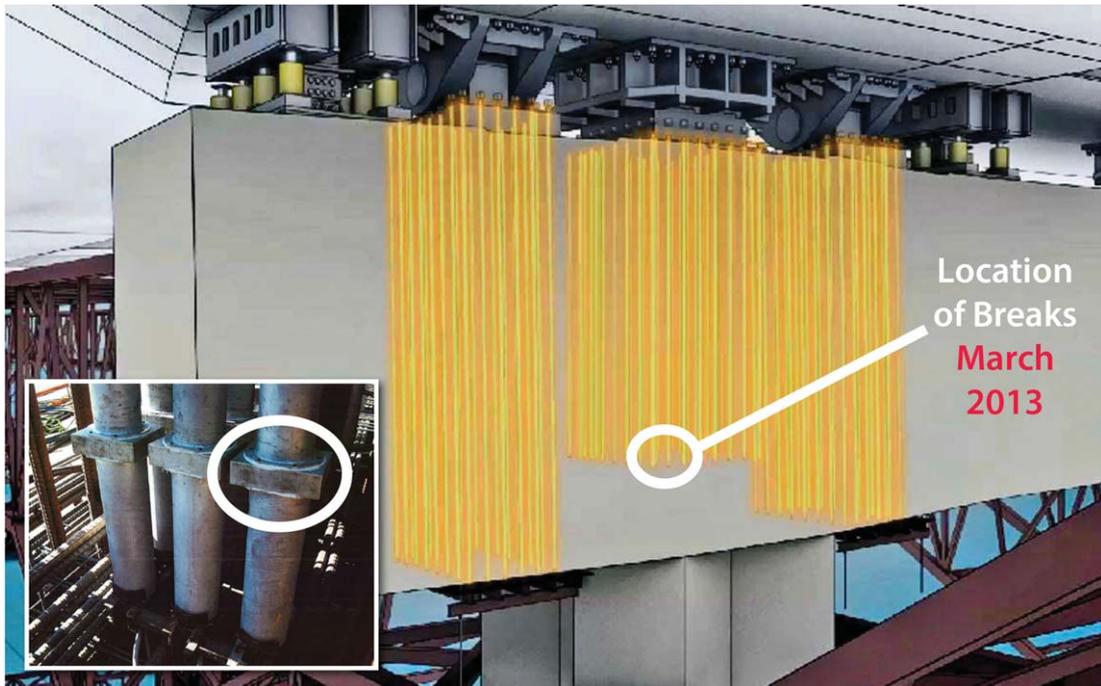
During the first two weeks of March 2013, 32 of the 96 three-inch-diameter, ASTM A354 Grade BD (A354BD) high-strength rods at Pier E2 fractured at their lower ends where they had been exposed to water accumulated in the duct. These rods were used to tie down the S1 and S2 shear keys of the Self-Anchored Suspension (SAS) bridge superstructure to the east pier. The fractures occurred a few days after the rod tensioning, and a few months before the scheduled opening of the New East Span of the San Francisco-

Oakland Bay Bridge (SFOBB). With a 33% failure rate, decision was made to abandon all of these 96 rods at Shear Keys S1 and S2, and an alternative anchoring system was designed and constructed. In addition, the California Department of Transportation undertook a testing program of unprecedented breadth and depth to ascertain the cause of the rod failures and to evaluate the suitability of all remaining A354BD rods on the bridge. See Figs. 1 and 2.

Fig. 2. Fractured rod locations at S1 and S2 shear keys at pier 2.

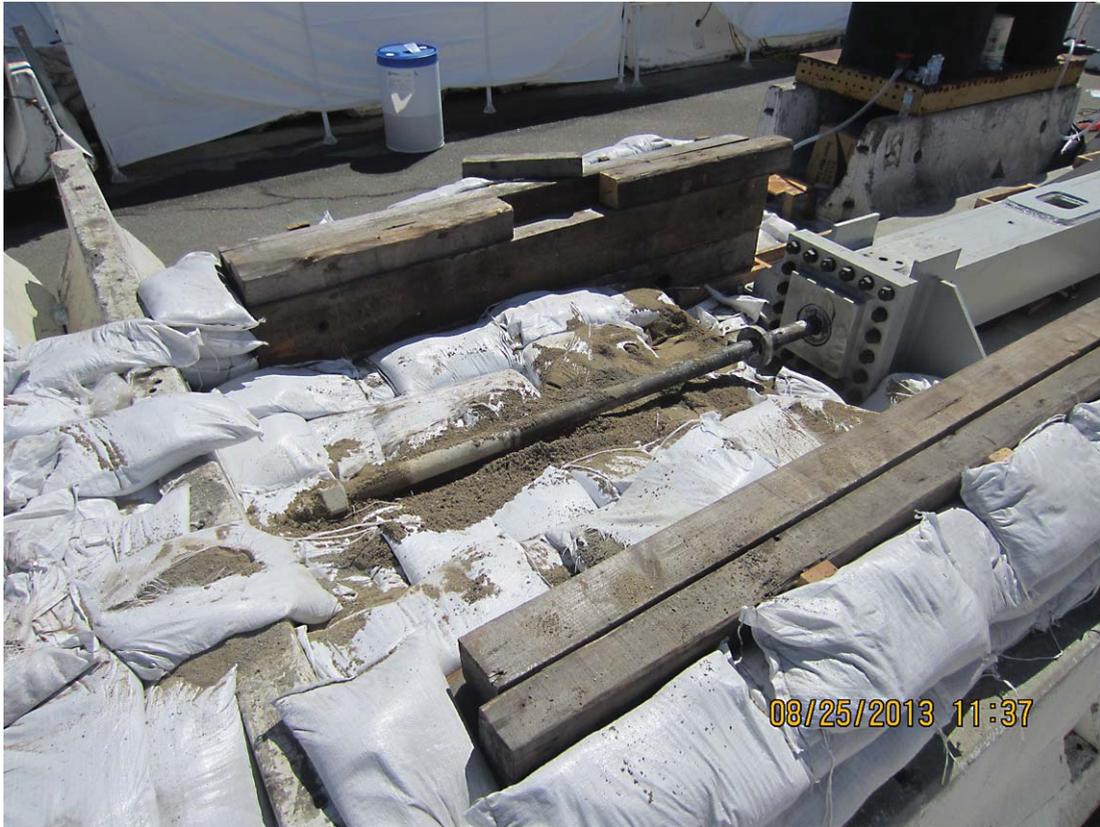
Fig. 6. Test rig after rod failure showing the effects of energy released when fracture occurs.

Figures 4 and 5 showed overall views of the test set-ups. Figure 5 also shows tanks of NaCl solution, a siphon system which replenished solution continuously, and provided access on the stressing end to tighten the nut. Figure 6 shows the test rig and the rod at the end of the test, after fracture.

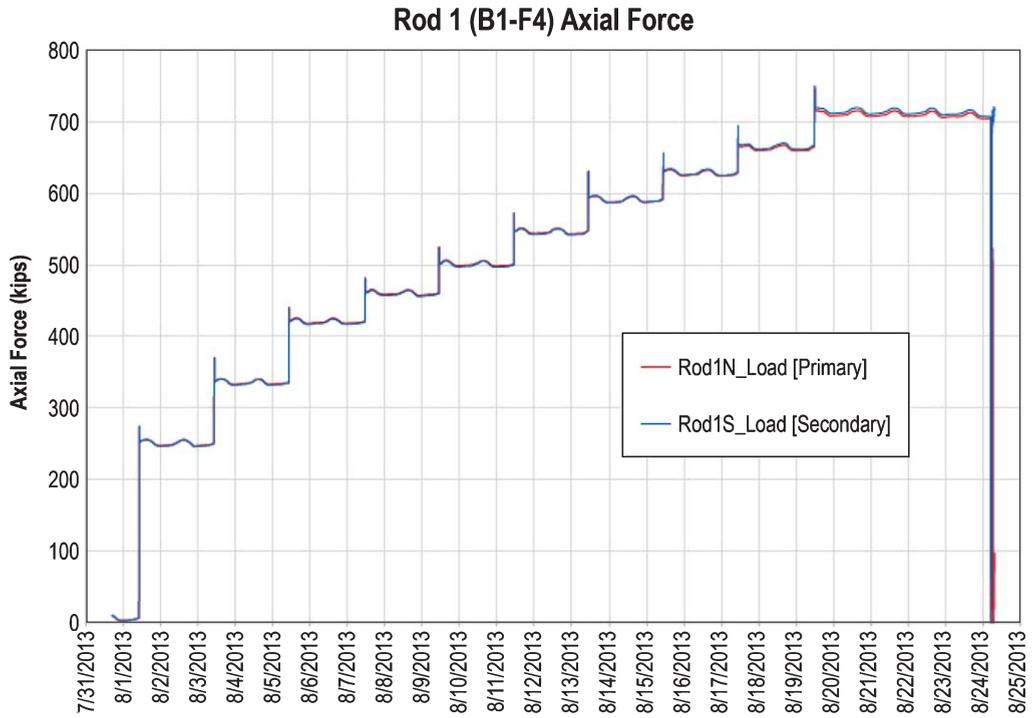
A typical loading sequence is shown in Fig. 8. In this case, the load was increased stepwise to 0.85 Fu, where it was held until it fractured after 113 hours.

Fig. 8. Typical plot of load vs. test time, showing step increases in load until failure at 0.85 Fu (Rod 1).

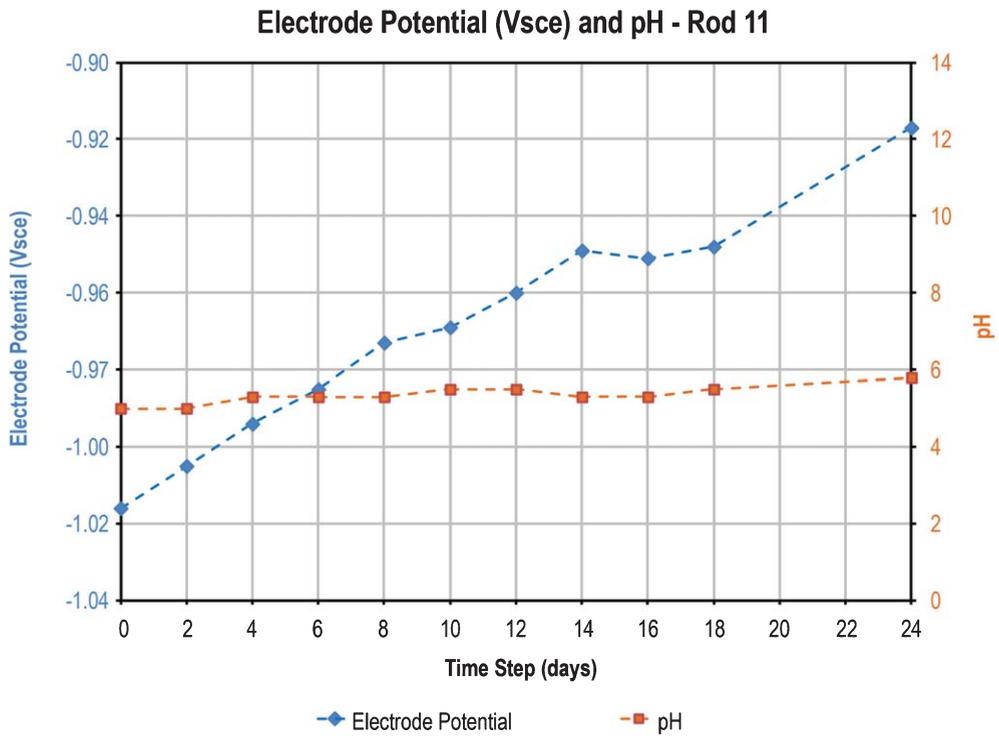
Electrode potentials of the rods and pH of the test solution typically varied during the course of the test as typified by Fig. 9. A slight increase in pH with time was attributable to the buildup of zinc ions in solution resulting from corrosion of the galvanized rod.

Electrode potentials measured during testing of the rods generally started at a level that is significantly less negative than the potential of -1.06 V_{sce} normally exhibited by pure zinc and ordinary galvanized coatings. This result can be attributed to the composition and structure of the galvanized rod coatings, which were found to consist mainly of iron-zinc intermetallic compounds. The fact that the potentials of the iron-zinc intermetallic compounds are less negative than pure zinc means that galvanic activity and driving force for hydrogen evolution are also reduced.

Figure 9 also shows that the electrode potential becomes less negative with time during the test. This rise is consistent with the selective dissolution of zinc from the coating, leaving behind a coating increasingly rich in iron, and less galvanic.

Fig. 9. Example plot of electrode potential and pH vs. test time (Rod 11).

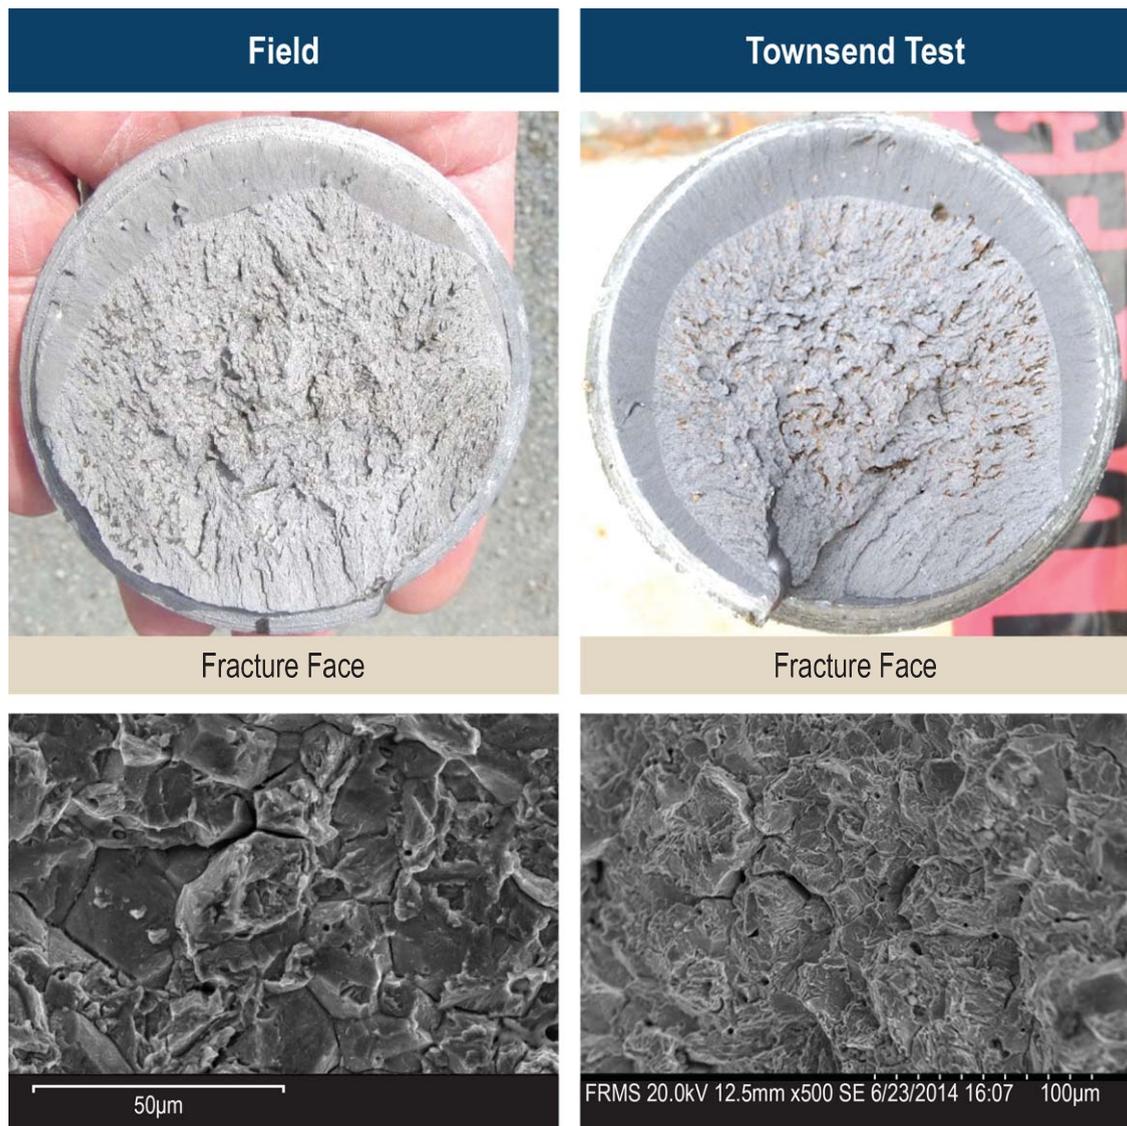
A comparison between the results for Rods 8 and 9 (rolled threads) and those for Rods 10 and 11 (cut threads) indicates that the EHE resistance of rolled threads is superior to that of cut threads. This is consistent with the work of others [3] who have found that thread rolling after heat treatment significantly increases resistance to stress corrosion cracking, owing to cold work and residual compressive stresses

Fig. 10. Townsend test results comparison.

created at thread roots as a result of the thread rolling process.

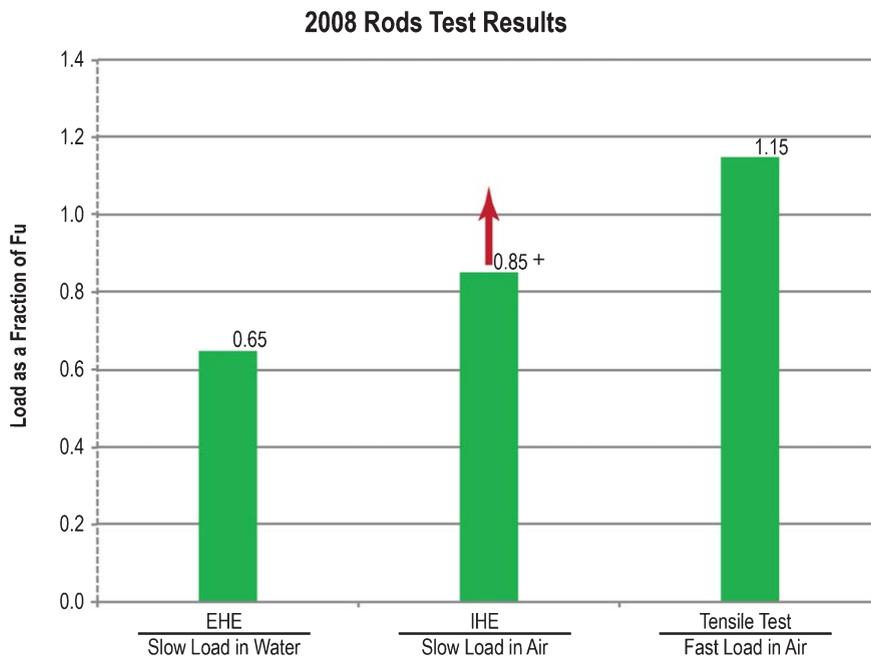
Both 2008 Rods failed at loads of 0.70 Fu, which indicates a threshold of 0.65 Fu. The macroscopic appearance of the fracture surfaces, and the intergranular nature of the fracture surface observed in the SEM, indicate that these rods failed by a hydrogen embrittlement mechanism. Given that the results of Phase 5 (as discussed below) show that the IHE threshold for this group of rods is significantly higher than 0.65 Fu, it can be unequivocally concluded that the rods in Phase 3 failed solely as a result of EHE. The similarities both in failure loads (0.70 Fu) and fracture appearances of the 2008 Rods in the test and that of the failures of the 2008 Rods that occurred on Pier E2 (see Fig. 10) demonstrate that the test is duplicating hydrogen damage as observed with the fractures of the 2008 Rods. It also demonstrates that soaking in corrosive water for long times is not necessary to produce EHE.

Figure 11 provides an overview of the test results for the 2008 Rods. As seen in the illustration, threshold level varied based on the environments in which they were tested.

Fig. 11. 2008 Test thresholds vs. actual loading.

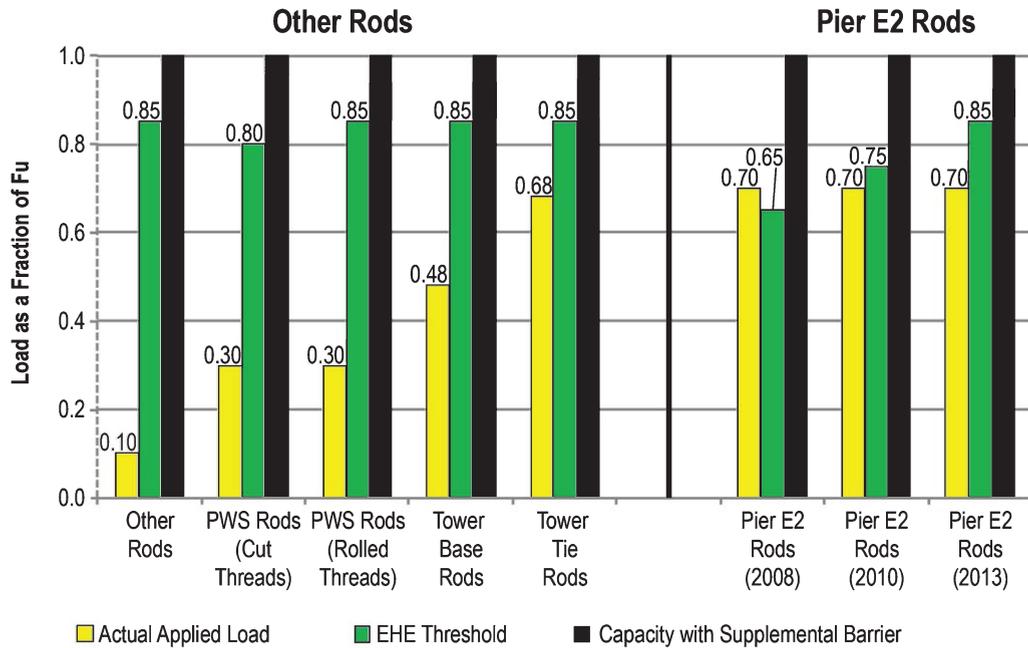
Fig. 12. EHE threshold, applied load, and capacity with supplemental barrier.

As shown in Fig. 12, the pretension load of the 2008 Rods (0.70 Fu) is higher than the corresponding EHE threshold (0.65 Fu), which is consistent with the failures that occurred at Pier E2. More importantly, these figures show that the design loads of all rods presently in service on the SAS are less than the corresponding SCC threshold levels determined in the test, and that with a supplemental corrosion barrier, the long term capacity of the A354BD rods is 1.0 Fu or greater.
