Automation under suspicion – case flight AF-447 Air France

Edgard Martins¹ and Marcelo Soares²

Keywords: processing information; human error; training

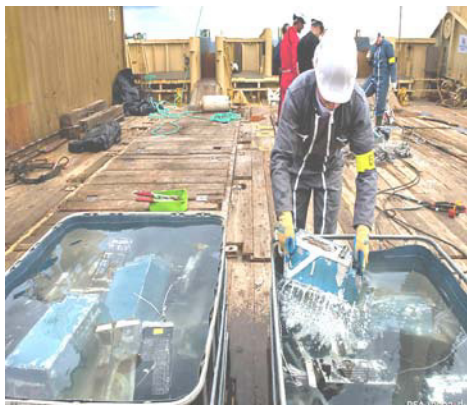
have stopped the plane. The probes allow the pilot to control the speed of the aircraft, a crucial element in the balance of the flight. The crash of the Air France flight AF447 on May 31, 2009, was due to pilot error and usual procedures. Preliminary analysis results of black boxes reads: "Airbus pilots were apparently distracted by speed indicators problems and did not react properly against other crucial elements of the flight, as the pressure setting the aircraft,". The figure 2 presents the black-box of the AF- 447.

Figure 2 – The rescued black-box of the Air France 447 flight.

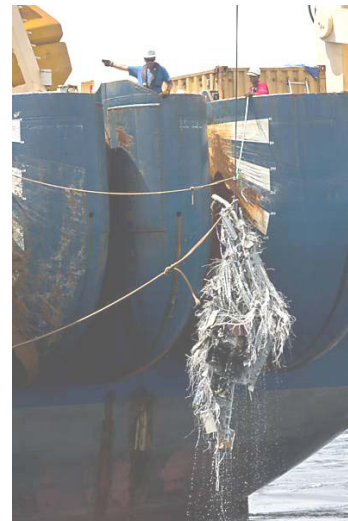
But the group of lawyers Franco-Brazilian states that is based on a theory proposed by independent experts, "which tends to demonstrate that the design of the plane would have exercised a not inconsiderable role in the disaster." These messages revealed a number of important operational errors in a zone of turbulence, "making the plane uncontrollable and have led to a rapid depressurization of the unit," according to the report of these experts. This event would have caused "an escape of compressed air from the cockpit of the device, then the loss of the stabilizer wing, pulled under the effect of speed (900 km / h), and the breakdown of the movement limiter direction pointed to 2:10 a.m. (UTC abbreviation for Coordinated Universal Time) by ACARS messages," the statement added. According to these experts, the depressurization would have been so great and swift that would have caused an explosion, leading to a destruction of the aft fuselage of the plane. The figure 3 gives us a short idea of the destruction of the airplane.

Figure 3- the rescue of the fuselage of the AF- 447

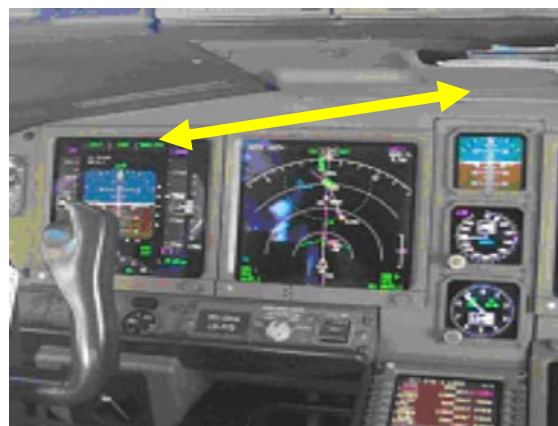
Does the Attitude Indicator (Artificial Horizon for the Jurassic and laity) also crashed? Only in this way to understand this gives total disorientation. Some aircraft keeps the main tools, duplicate the main panel, to assure a safe alternative system in case of power outage. It is seen in figure 4 aircraft with these duplicate analog and digital devices.

Figure 4- This "Glass Display" have, in addition, the AI (Attitude Indicator) and a few other instruments, also permanent and analog-to-measure and safety

The FAA (Federation Aviation Administration) also reinforces the need for instruments Stand by Stand by ASI and ALT (altimeter and speedometer) are purely mechanical in a separate system. With these three instruments over the compass the plane has the primary instruments for the crew to fly the aircraft in an emergency situation of loss of electrical power or in case of loss like the af-447. If it not crashed, the plane was shot down we have a significant contribution of the pitot-static system [2].
