Stair safety: bottom of flight illusion

Abstract. Falls near the bottom of a flight of stairs have resulted from an illusion that the person was stepping off onto the bottom landing when the person was still two treads or more above the landing. The illusion is caused by poor lighting and design defects built into the stairway. The poor lighting may be attributed to a building code that allows inadequate lighting near the bottom of external stairs in private residences. The design defect of truncating handrails before they reach the bottom tread may be due to confusion between “guards” and “handrails” and this confusion also appears to be promulgated by building code.

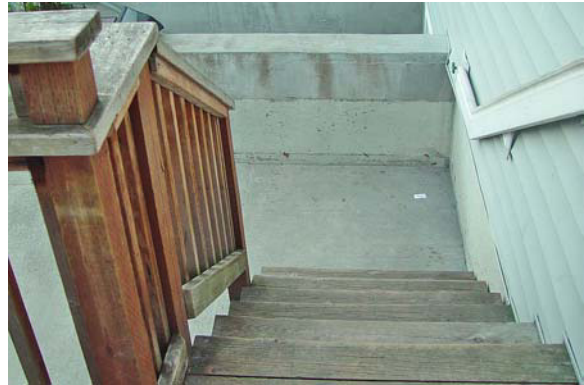
An example of the design of the external staircase that was poorly illuminated and which was implicated in a fall when a woman was descending the stairs is seen in Figure 1. She had her hand on the left handrail. The handrail on the right was of little use since it was too close (13 mm, 0.5 in) to the wall for her hand to follow. When she was near the bottom of the “pitch black” stairway she stepped off to her left onto what she thought was a lower landing (see Figure 2.) She fell and fractured an ankle.

Fig. 1. A woman was descending this darkened stairway and stepped off to her left onto what she thought was the bottom landing.

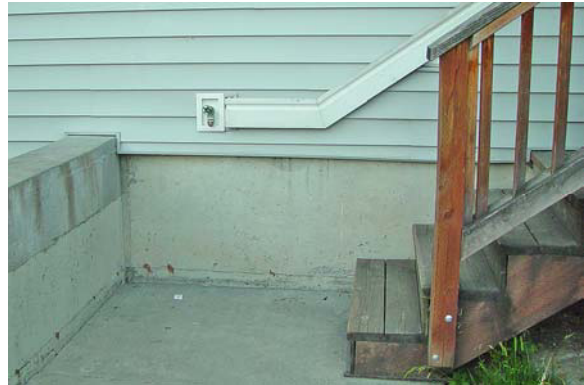
Fig. 2. She was not aware the handrail on her left ended before the bottom landing.

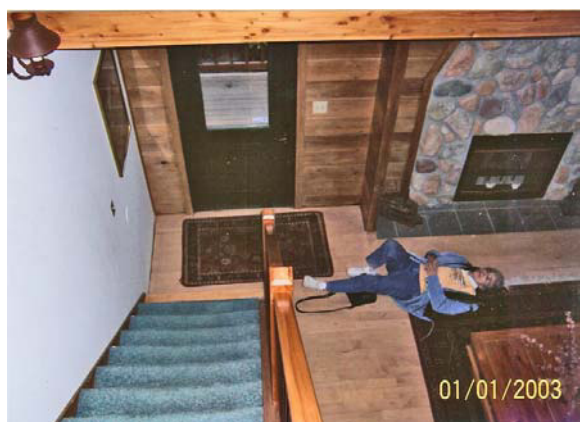
Fig. 3. A relative took this photograph soon after the woman fell. The bottom tread resembles the bottom landing. (Photo used with permission. Date stamp is incorrect.)

As can be seen in Figure 3, from above the bottom tread was of the same appearance as the bottom landing. All the other treads were carpeted and the handrail stopped two treads above the bottom landing. These cues apparently led her to believe that when she stepped onto the bottom tread she was stepping onto the bottom landing (see Figure 4). As she fell she grabbed for the handrail but it truncated a step above the bottom tread. She fractured her left proximal femur.

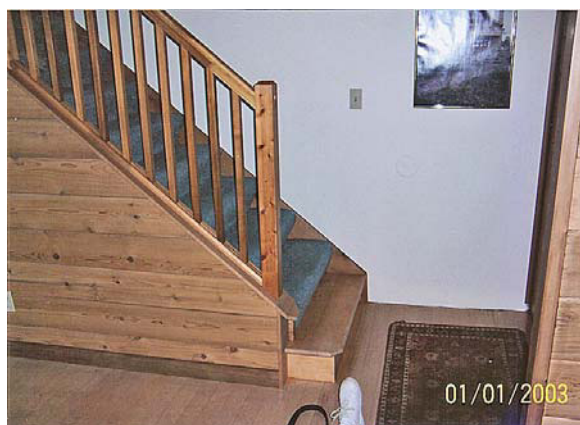
Fig. 4. The bottom tread, difficult to discriminate from the landing when a person is on the stairs, is obvious in profile. (Photo used with permission. Date stamp is incorrect.)

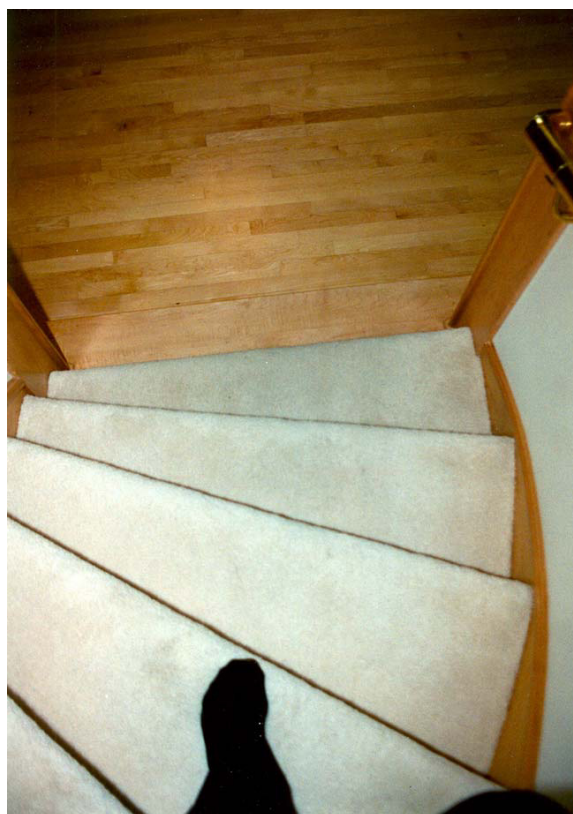
In a similar incident a 51-year-old woman was descending a stairway she had never been on before. The lighting was subdued. Figure 5 shows what was visible to her as she approached the bottom landing.

Fig. 5. As seen from above the stairs and the lower landing are quite apparent. The bottom tread is not conspicuous. (The photographer's foot, however, is.)

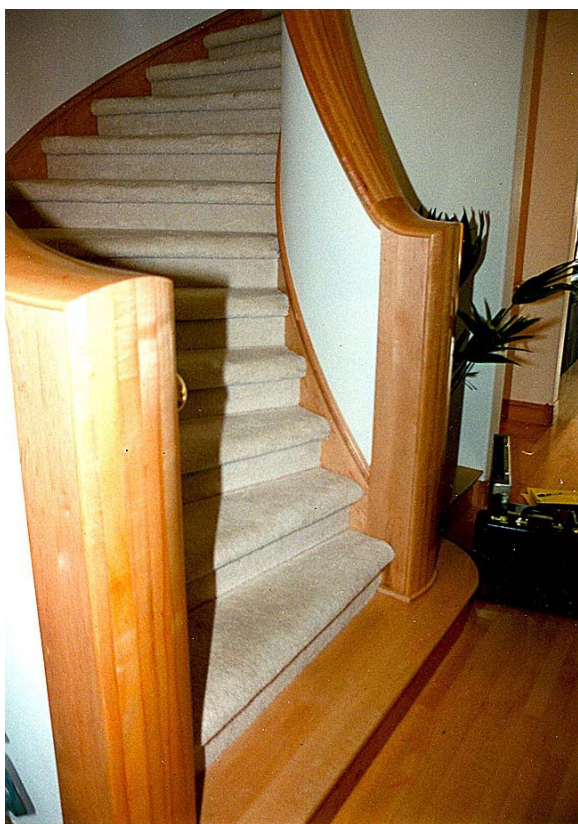
When she placed her foot on the wooden tread it pivoted and slid over the nosing. When her foot impacted the lower landing it resulted in a Lisfranc fracture of her foot. Again, in profile, the bottom tread is obvious (see Figure 6). Further, the hard-to-grasp handrail did not extend to the bottom nosing.

Fig. 6. In profile the bottom tread is obvious. Notice that the handrails stop short of the bottom nosing.
