Ergonomic and usability analysis on a sample of automobile dashboards

Abstract. This is a research study based on an analysis which sets out to identify and pinpoint ergonomic and usability problems found in a sample of automobile dashboards. The sample consisted of three dashboards, of three different makes and characterized as being a popular model, an average model and a luxury model. The examination was conducted by observation, with the aid of photography, notes and open interview, questionnaires and performing tasks with users, the bases of which are on the principles laid down by methodologies. From this it was possible to point to the existence of problems such as: complaints about the layout, lighting, colors, available area, difficult access to points of interaction, such as buttons, and the difficult nomenclature of dials. Later, the findings and recommendations presented show the need for a further, deeper study, using more accurate tools, a larger sample of users, and an anthropometric study focused on the dashboard, since reading and understanding it have to be done quickly and accurately, and that more attention be given to the study of automobile dashboards, partic

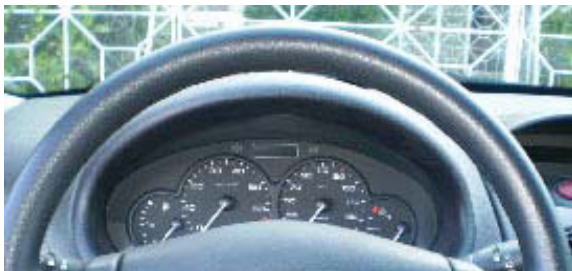
Figure 1 – Dashboard of Peugeot 206

4.1. Peugeot 206 –popular model (Figure 1)

– Serious Impact: instrument problems (reflection of light, preventing the display of certain indicators),

cognitive problems (the existence of new symbols that do not have a close relationship with what they represent, so that their meanings are ignored) and instructional problems (manual for the panel is complex as to explaining the symbols and their nomenclature);

- Medium impact: problems of movement (the hands of the dials cover the corresponding number, making it difficult to read), of posture (line of sight of the panel is affected by the limitation on seat adjustment and steering) and of informational (proximity of icons of similar representation cause the risk of a misreading);

- Mild impact: problems of interaction (access to the headlight adjustment) of resistance (the panel suffers with direct physical aggression and is prone to chemical corrosion), of biology (environment in which it is located is prone to dirt accumulating, both in its protective covering and on its base), of interaction (text messages that appear are time consuming and long), of dimensions (distribution of symbols and dials on the panel is not suitable) and of perception (lack of proximity to the arrows indicating direction with one's hands).

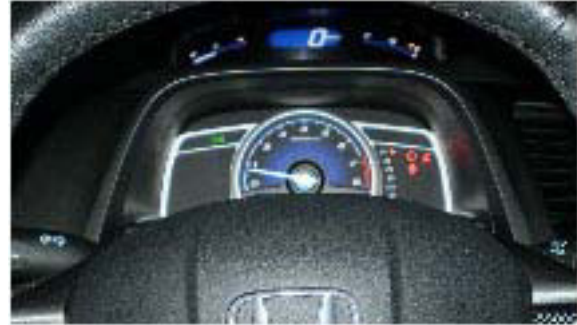
Figure 2 – Dashboard of Honda Civic

4.2. Honda Civic – average model (Figure 2)

- Severe Impact: information problems (information provided in a foreign language) and instructional problems (lack of clarity in explaining the functions and meanings of the signs of the panel);

- Medium impact: problems of viewing (some signs are obscured by the illumination of the neighboring sign), of movement (there are a large number of levers and handles for the reactions to the information provided by the panel), of perception (although there is a sound signal, it is not perceived due to its low volume), of instruments (little space for distributing the signs on the panel, which hinders the dissociation of the images) and of dimensions (discre-

pancy in prioritizing the functions as to the size in which they are presented);

- Mild impact: problems of instruments (the extra pieces of information passed on by the mileage meter is quite confusing for the user) of resistance (panel suffers with direct physical aggression and is prone to chemical corrosion), of biology (environment in which it is located is conducive to the accumulation of dirt, both in its protective covers and in its base), of interaction (the captions on the handles are very similar which confuses the driver), of dimensions (the small size of the mileage meter makes reading it difficult), of cognition (insertion of new icons that have no direct association with their meaning makes them hard to read, and the use of extremely similar signs to relate different functions) and of psychoneurophysics (the indicator of the level of very low fuel is triggered too early, and disturbs the driver).

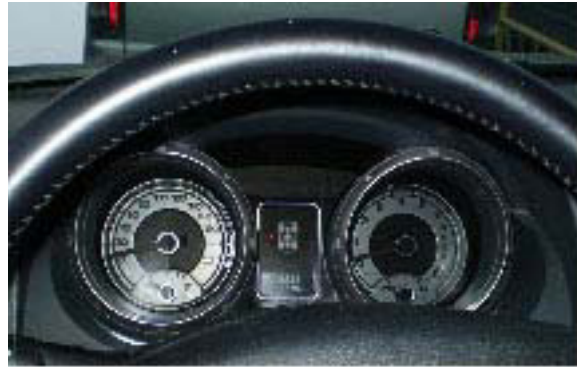
Figure 3 – Dashboard of Mitsubishi Pajero

4.3. Mitsubishi Pajero Full –deluxe model (Figure 3)

- Serious impact: semiological problems (due to the large number of new signs and captions it is necessary to have full knowledge of all of them and of the manual to manage to drive the car satisfactorily) and instrumental problems (little space for the luminous panel signs);
- Medium impact: problems of instruments (there was a bad choice of prioritizing the application of the dials), of dimensions (the area set aside for the panel is quite small), of viewing ("heavy" and dark chromatic choice, it is tiring to the eye and difficult to read), of interaction (the appearance of new buttons for new technologies, with their captions which are difficult to understand), of movement (the pointers of the largest dials cover the numbers indicated and of the smallest dials do not get close enough to a dis-

tance that makes them easy to read) and of perception (the frames of the analog displays are very large and hinder viewing the other dials and signs);

- Mild impact: problems of cognition (insertion of several new signs which most users are not used to), of resistance (panel suffers with direct physical aggression and is prone to chemical corrosion), of biology (environment in which it is subject to the accumulation of dirt, both in its protective covering and at its base), and of instruction (appearance of items present also in other models, but in this one they differ in their representation).
